PUBLIC ROADS

APRIL 1939

Page
Experimental Bituminous-Treated Surfaces on Sand-Clay and Marl Bases	21

A BITUMINOUS TREATED EXPERIMENTAL ROAD was built in Berkeley County, South Carolina, in 1929 by the State highway department and the Bureau of Public Roads to obtain information on sand-clay and marl as base materials and on the comparative value of various bituminous materials and methods of construction. This experimental road is still in service and a considerable portion of it is in good condition at the present time. It has been maintained with only such changes as have been brought about by the application of necessary re-treatments and maintenance that have been required to keep it in reasonably good condition at all times. The record of its construction, maintenance, and service behavior, provides an opportunity for the study of a number of factors upon which information was desired.

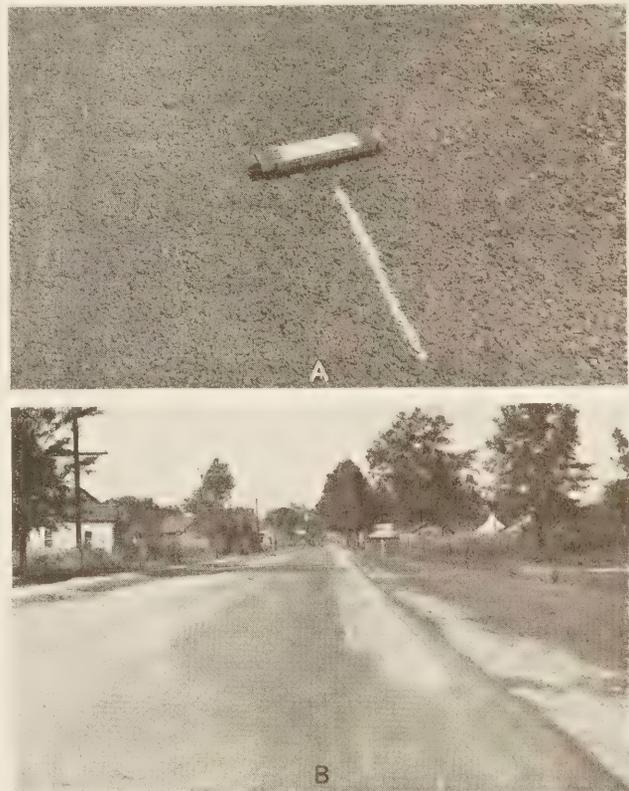
When inspected in October 1936, the section was in very good condition. The edges were unbroken and showed no considerable tendency to ravel although they were not well supported by shoulder material. The surface had a rather mottled appearance but it was smooth, very dense, and had a nonskid, coarse-grained texture as shown in figure 3-A. The general appearance of the section at the time of inspection is illustrated by figure 3-B, a view taken near the west end of the section.

FIGURE 3.—APPEARANCE OF EXPERIMENT 1A IN OCTOBER 1936. A, CLOSE-UP VIEW SHOWING NON-SKID SURFACE TEXTURE; B, GENERAL APPEARANCE OF SECTION. NOTE EVEN EDGES, DESPITE LACK OF PROTECTION BY SHOULDERS.

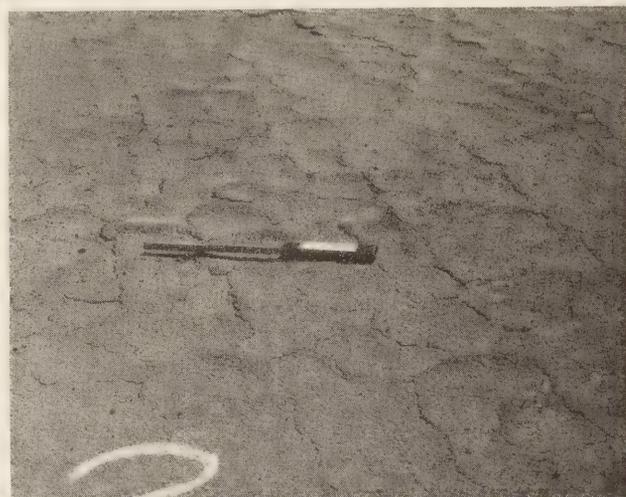
Later, however, a 100-foot section near the west end began to fail. The base became soft and spongy in spite of the French drains that had been installed. The bituminous mat cracked badly and patches placed to seal the cracks and prevent disintegration of the mat repeatedly failed until it became necessary practically to reconstruct this area. In August 1932, the marl base and bituminous mat were scarified, mixed together,

FIGURE 4.—SURFACE FAILURE ON EXPERIMENT 2A, PHOTOGRAPHED IN OCTOBER 1936.

The re-treatment was applied to the entire section in September 1935 but, after about 3 months, cracking again started and increased in amount and intensity so that another re-treatment was necessary. An inspection of the section made in October 1936, prior to applying the re-treatment, showed the section to be in poor condition. It had a number of badly broken areas of which one in the center of the business section of town was the worst. The mat in this area was not merely cracked but pieces had separated from each other and from the base. Sand had been washed into the cracks so that each piece appeared to be resting on a sand cushion. Figure 4 is an illustration of an area in this condition. Samples were taken of the marl base and of the subgrade and their analyses are given in table 1 under laboratory Nos. 10133 and 10134, respectively. The subgrade material was wet and sticky when sampled.

and relaid for compaction under traffic. In September this base was primed and a surface treatment applied.

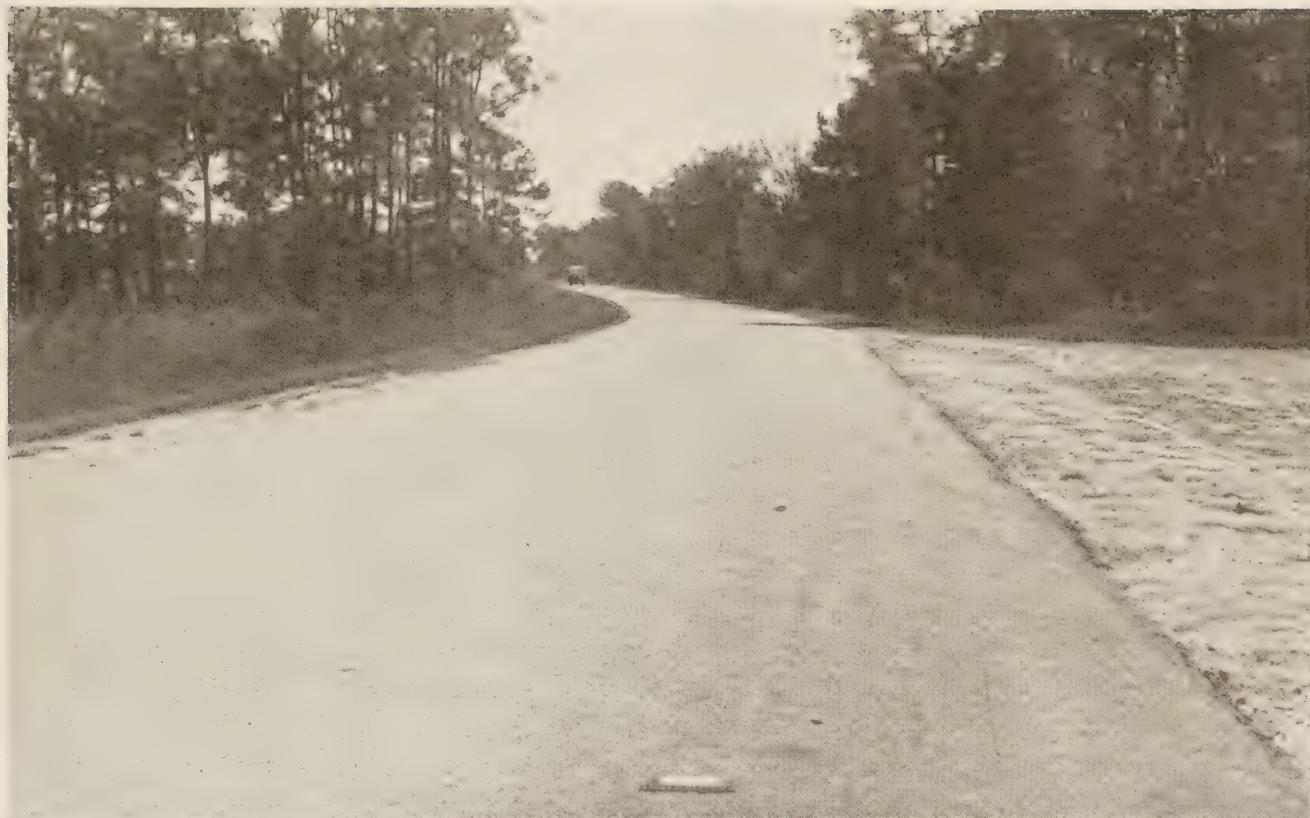
FIGURE 5.—GENERAL VIEW OF THE EAST PORTION OF EXPERIMENT 6A, WHICH IS TYPICAL OF THE ENTIRE SECTION. NOTE THE EVEN EDGES AND UNIFORM APPEARANCE.

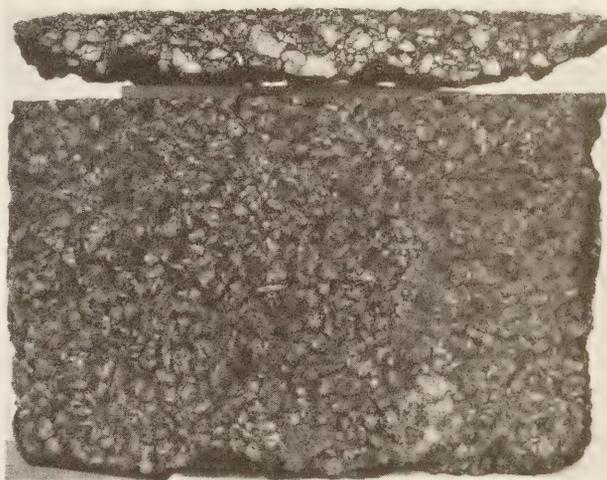
FIGURE 6.—APPEARANCE OF A SAMPLE OF THE SURFACE OF EXPERIMENT 6A IN APRIL 1937.

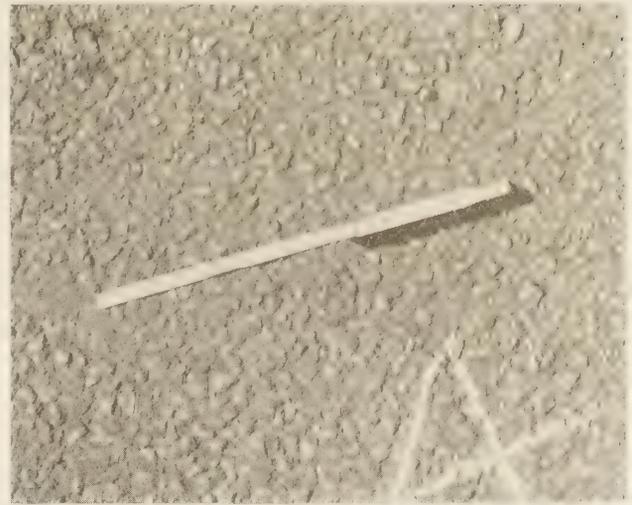
FIGURE 7.—CLOSE-UP VIEW OF THE SURFACE OF EXPERIMENT 7B. ALTHOUGH SOME PORTIONS RAVELED, OTHER PARTS RETAINED A CLOSED, NON-SKID SURFACE.

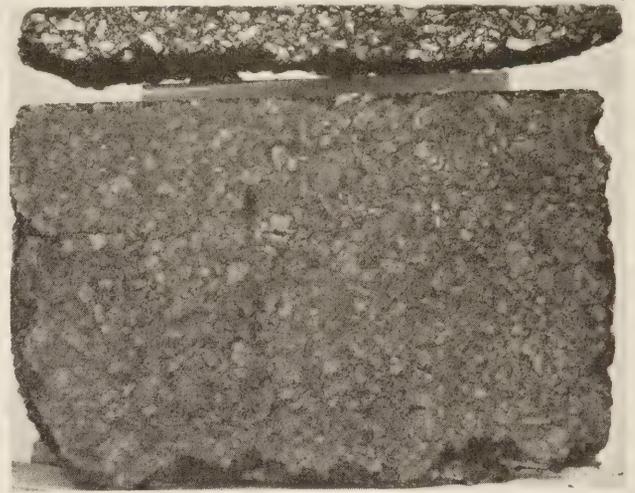
FIGURE 8.—APPEARANCE OF A SAMPLE OF THE SURFACE OF EXPERIMENT 8. THE CRACKS SHOWN WERE CAUSED BY HANDLING THE SAMPLE.

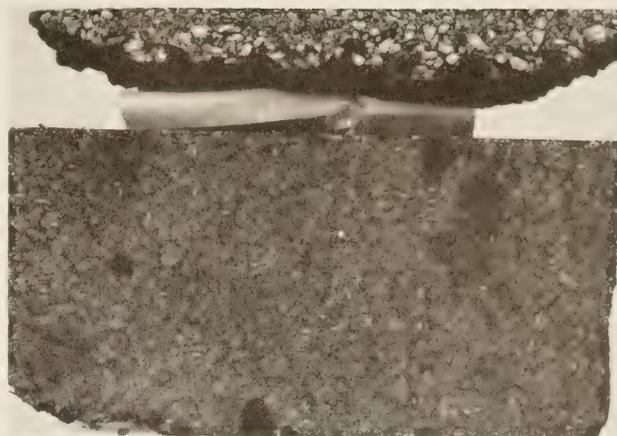
FIGURE 9.—APPEARANCE OF A SAMPLE OF THE SURFACE OF EXPERIMENT 9. THE CRACKS SHOWN WERE CAUSED BY HANDLING THE SAMPLE.

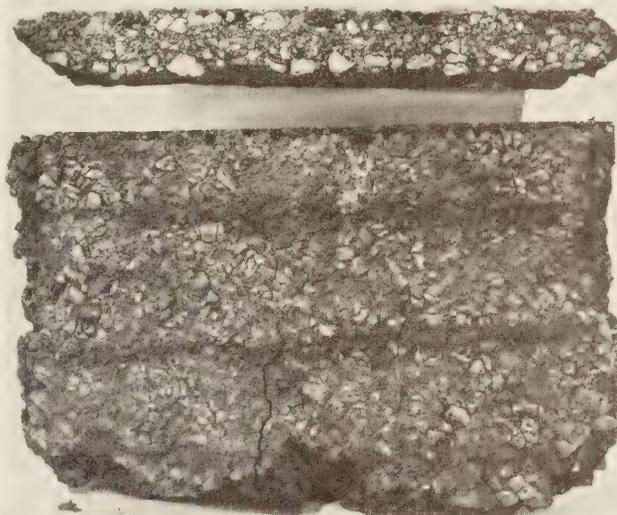
FIGURE 10.—APPEARANCE OF A SAMPLE OF THE SURFACE OF EXPERIMENT 10. THE CRACKS SHOWN WERE CAUSED BY HANDLING THE SAMPLE.

appearance of a typical area of the section. The analysis of the bituminous mat illustrated is given in table 8.
